FIELD REPORT

SLIPLINING WITH HDPE SAVES BIG CITY UTILITY MILLIONS

Miami-Dade Sewer Force Main Rehab

Emergency rehabilitation of 72-inch pre-stressed concrete cylinder pipe (PCCP) sewer force main.

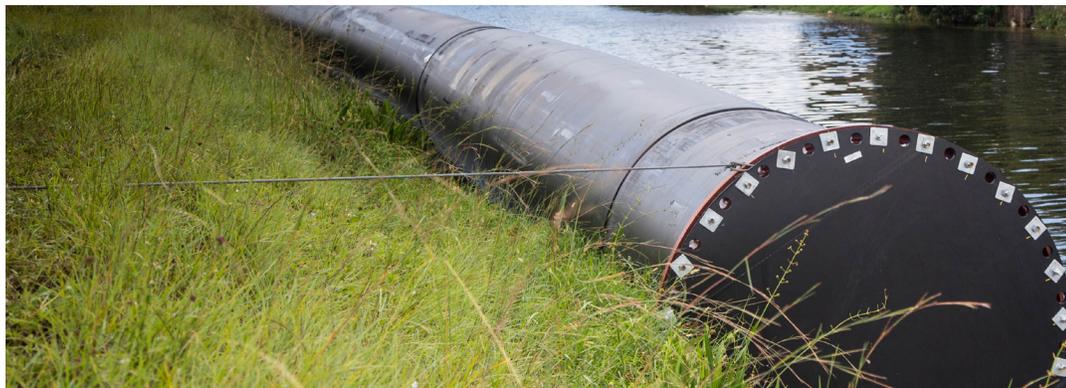
Sliplining with 63-inch HDPE saves sewer force main sections critically close to failure.

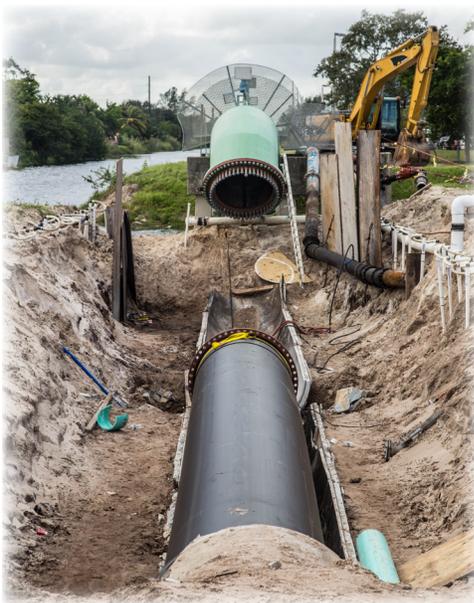
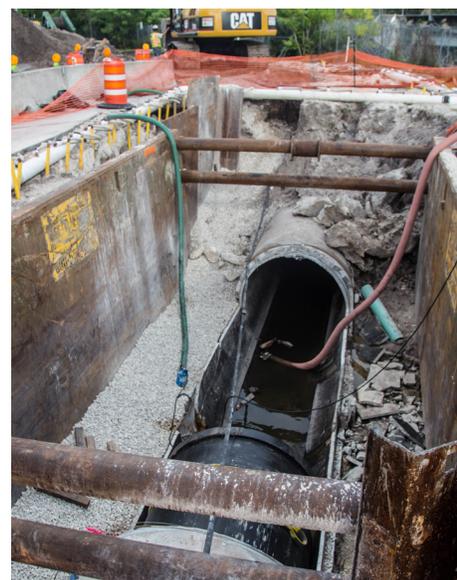
"The slipling of 17,160 LF of 72" PCCP with 63-inch DR32.5 HDPE was accomplished in 11 individual pulls ranging in length from about 600 feet to more than 3,000 LF which were installed in a variety of locations from along a canal bank to underneath Interstate 95 and down the middle of a residential street," explained Dan LaCross, project manager with Ric-Man Construction. The pulls that were installed along the bank of the canal were fused together and then floated in the canal until they were ready to be pulled into the host pipe. Connections were made between pulls by flange-to-flange.

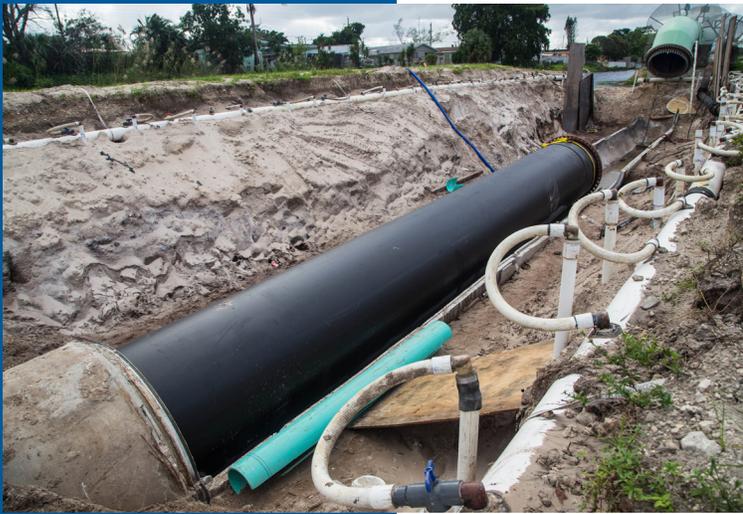
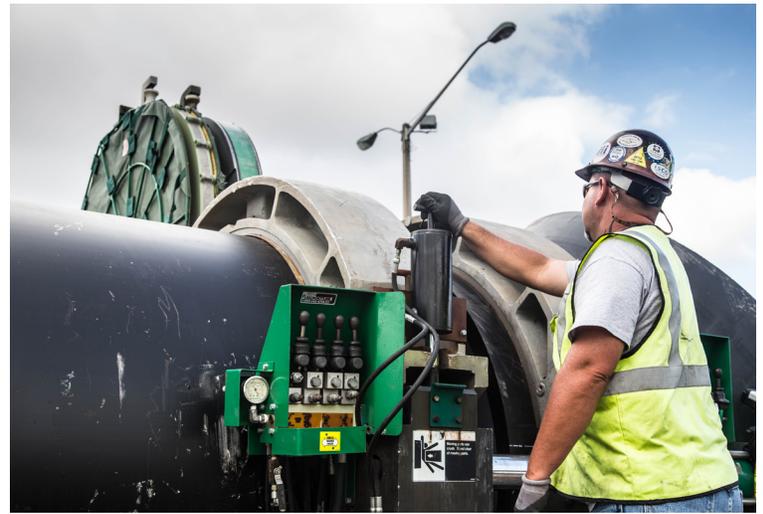
On the ends of the line, connections were made by flange-to-valve. There were also 48 air release valves (ARVs) and access man ways that needed to be installed on the 63-inch line within the host pipe. ISCO worked hand-in-hand with Ric-Man Construction to provide the most efficient means of making the ARVs and access man way connections to the HDPE. Lacross said, “ISCO supplied a qualified fusion technician and open communication from order placement to production to delivery and a hands on approach during the design phase for the required fittings and connection points between runs.”
